2021 SURVEY OF BONNEVILLE CUTTHROAT TROUT IN THE UPPER SEVIER RIVER DRAINAGE, UTAH

Publication Number 22-02

Utah Department of Natural Resources

Division of Wildlife Resources

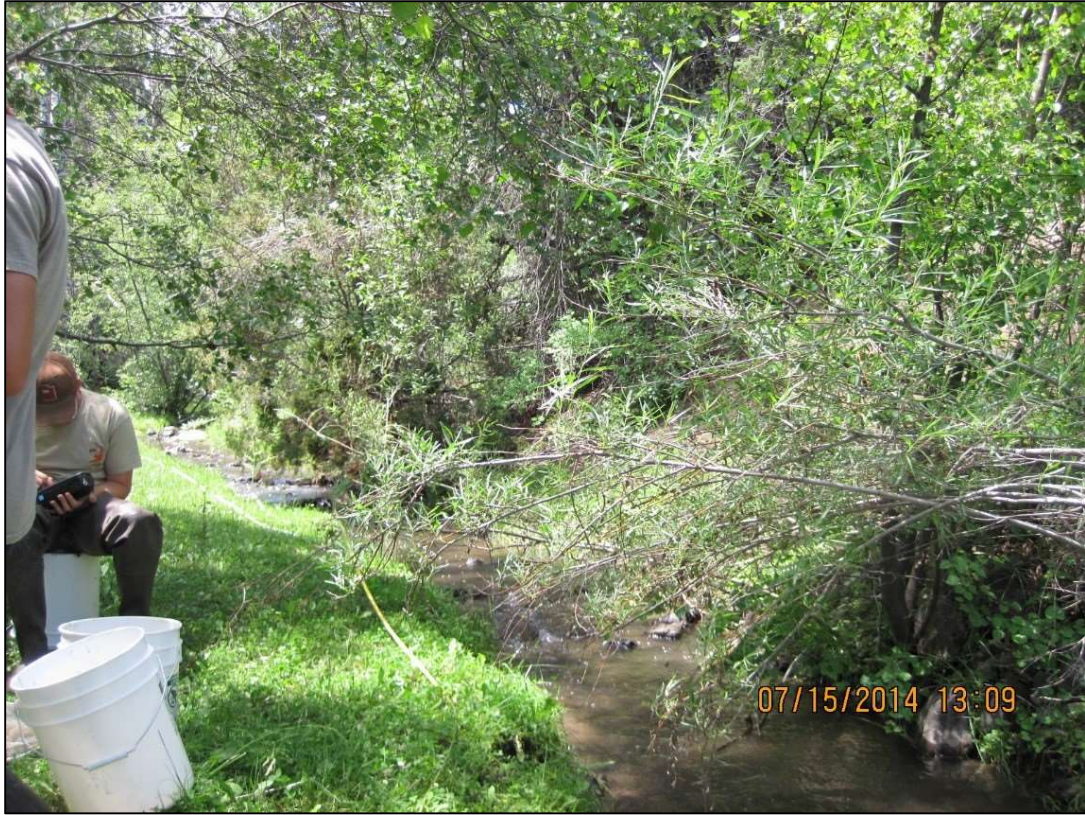
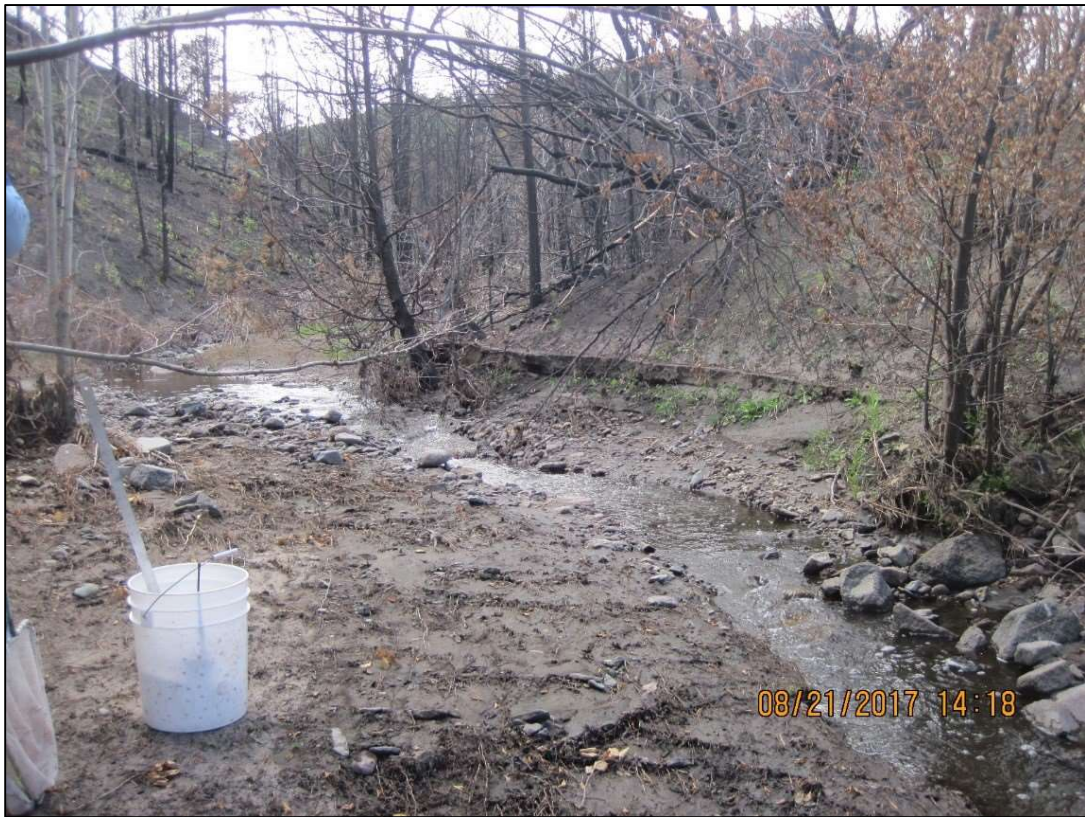
Creek was significant bed load movement and bank erosion (Fig. 3), while Threemile Creek mainly received the deposition of that Delong Creek sediment (Fig. 4). Sampling and other observations in late 2017 indicated that the BCT populations in Delong Creek, Indian Hollow, and Threemile Creek were all extirpated by the floods. Although the fire burned into portions of the Castle Creek and Mammoth Creek drainages, these streams did not experience the same level of flooding observed in other streams, most likely because the watershed area burned at moderate and high severity was relatively low (< 7%). The only immediate impact observed was the burning of about half of the dense willow thicket and beaver dam complex in upper Castle Valley.

Figure 3. Delong Creek, Station 1, before the Brian Head fire in 2014 (top) and after the fire in 2017 (bottom).

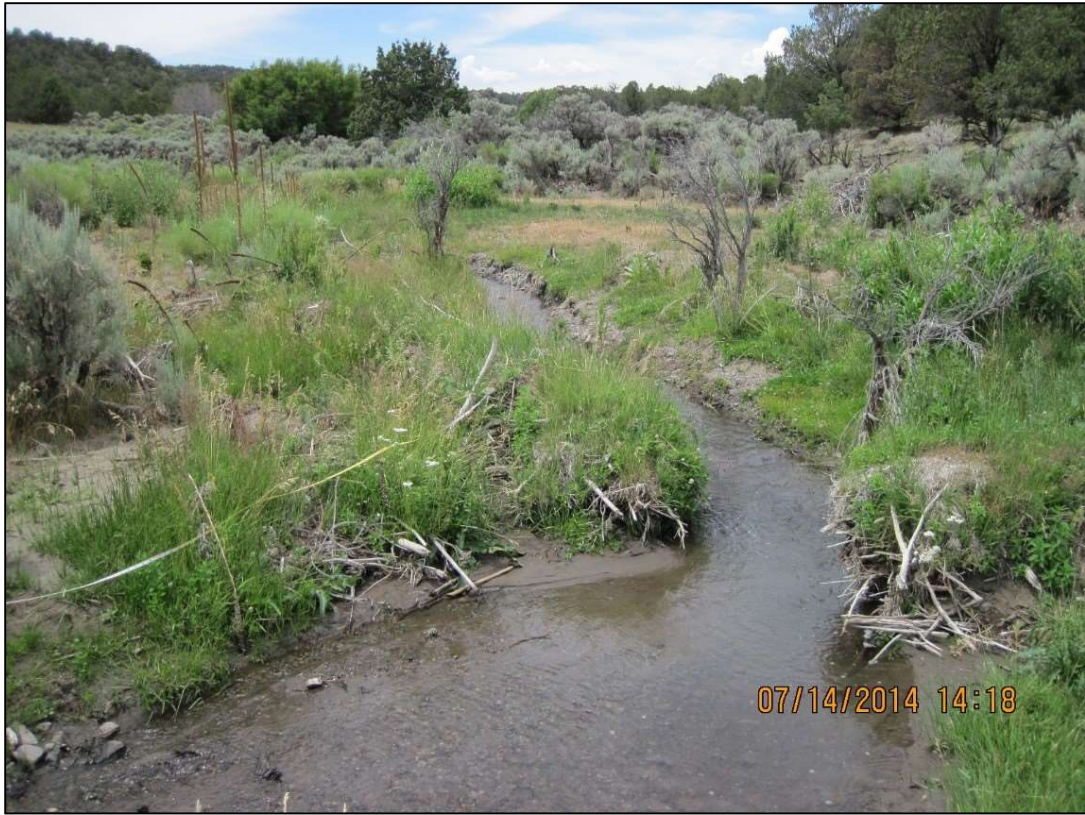
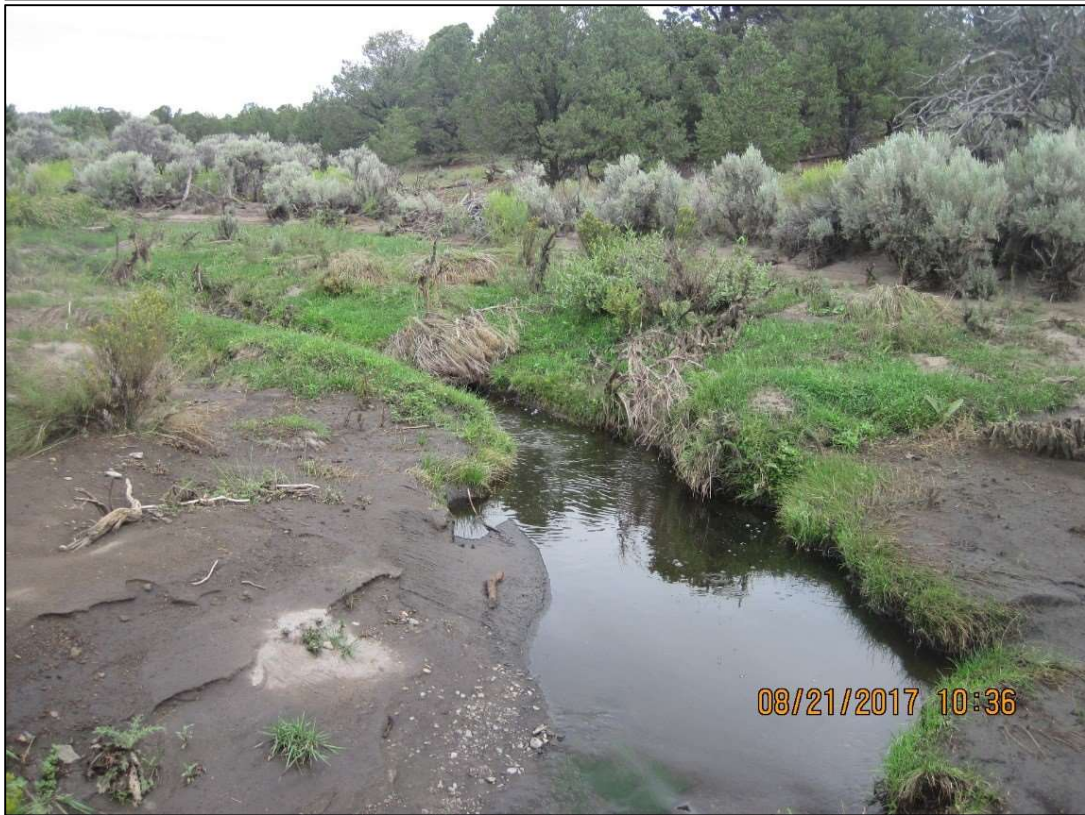
Figure 4. Threemile Creek, Station 1, before the Brian Head fire in 2014 (top) and after the fire in 2017 (bottom).

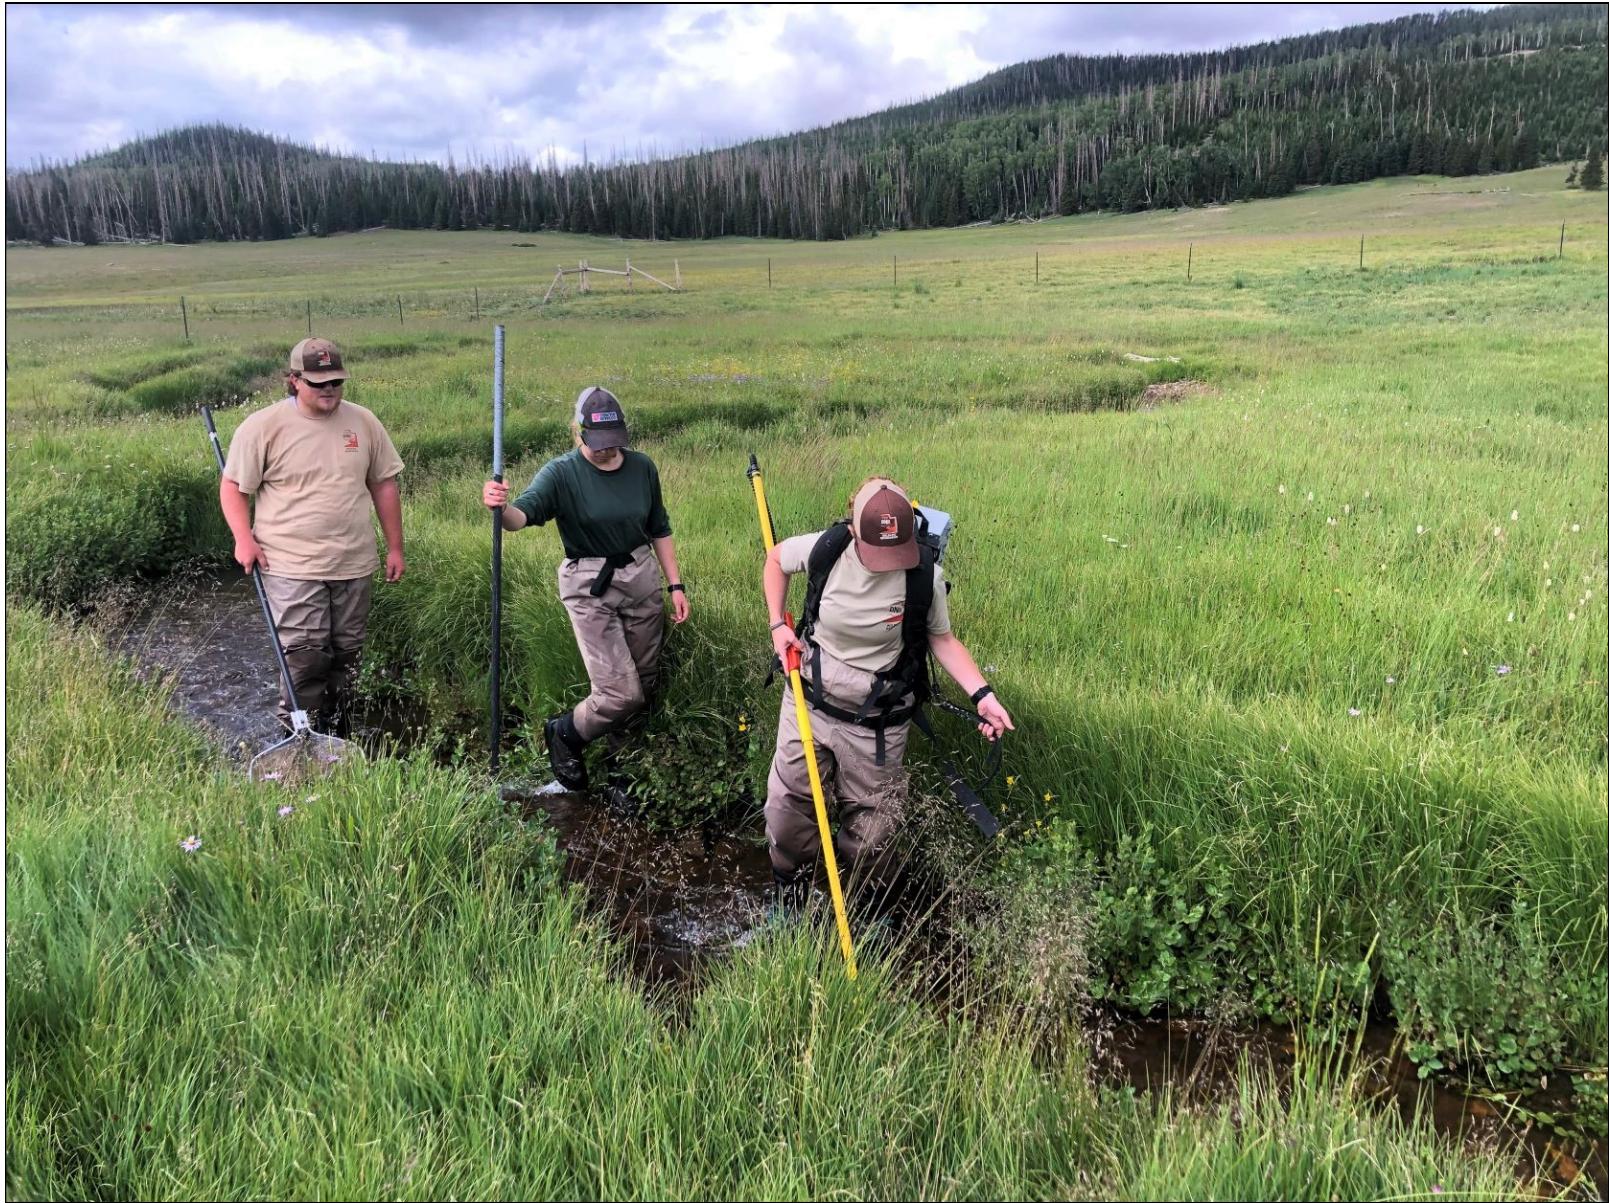
Complete population surveys were conducted during 2021 in Birch Creek, Castle Creek, Lowder Creek, Threemile Creek, and its tributaries. Standard protocol for BCT monitoring in the Southern Bonneville GMU calls for surveying all known populations within the selected drainage during a single field season (Hadley et al. 2015). However, the ongoing removal of nonnative trout and restoration of BCT in the Mammoth Creek drainage during 2021 precluded complete surveys in most of those streams, except Castle Creek and Lowder Creek, where BCT had been introduced in 2017. Although informal sampling had previously indicated that BCT were extirpated from Threemile Creek and its tributaries, survey stations were repeated in those streams in 2021 in order to formally document the population status. Fish populations were sampled using backpack electrofishing units (Smith-Root models 12-B, LR-20B, and/or LR-24) (Fig. 5). DWR, DNF, and

Figure 5. Personnel conduct an electrofishing survey in Castle Creek.

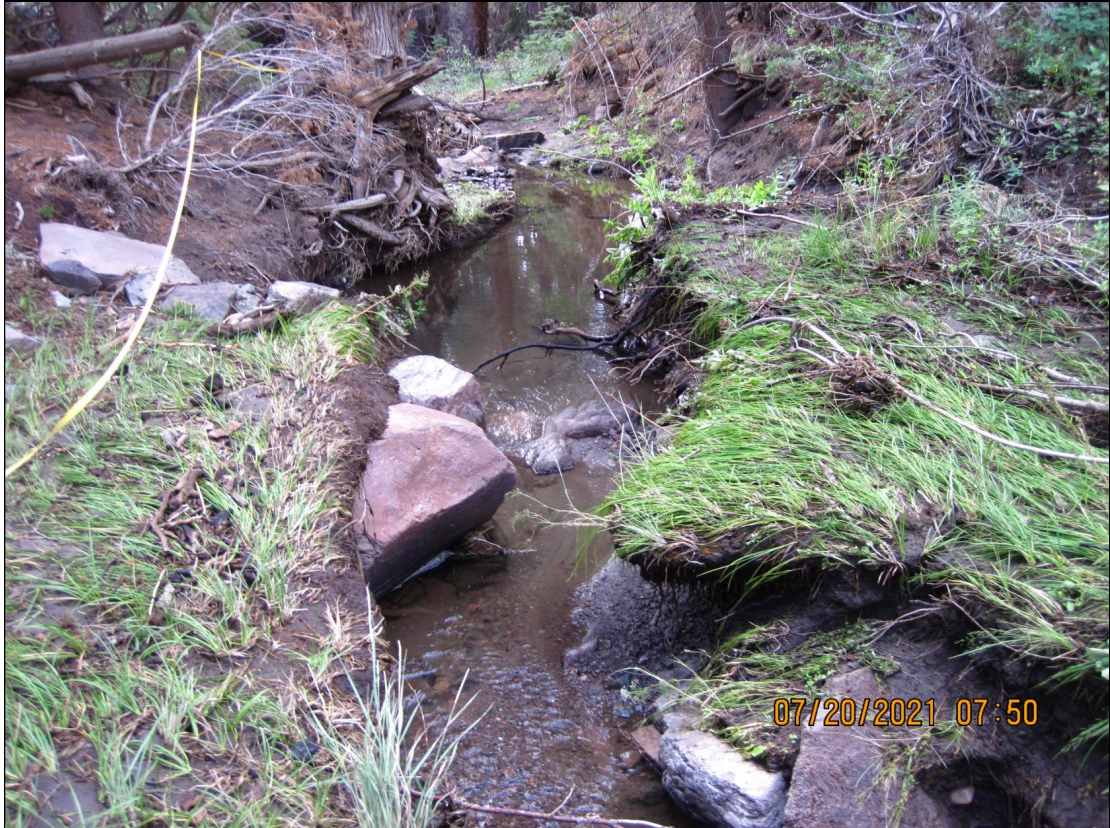
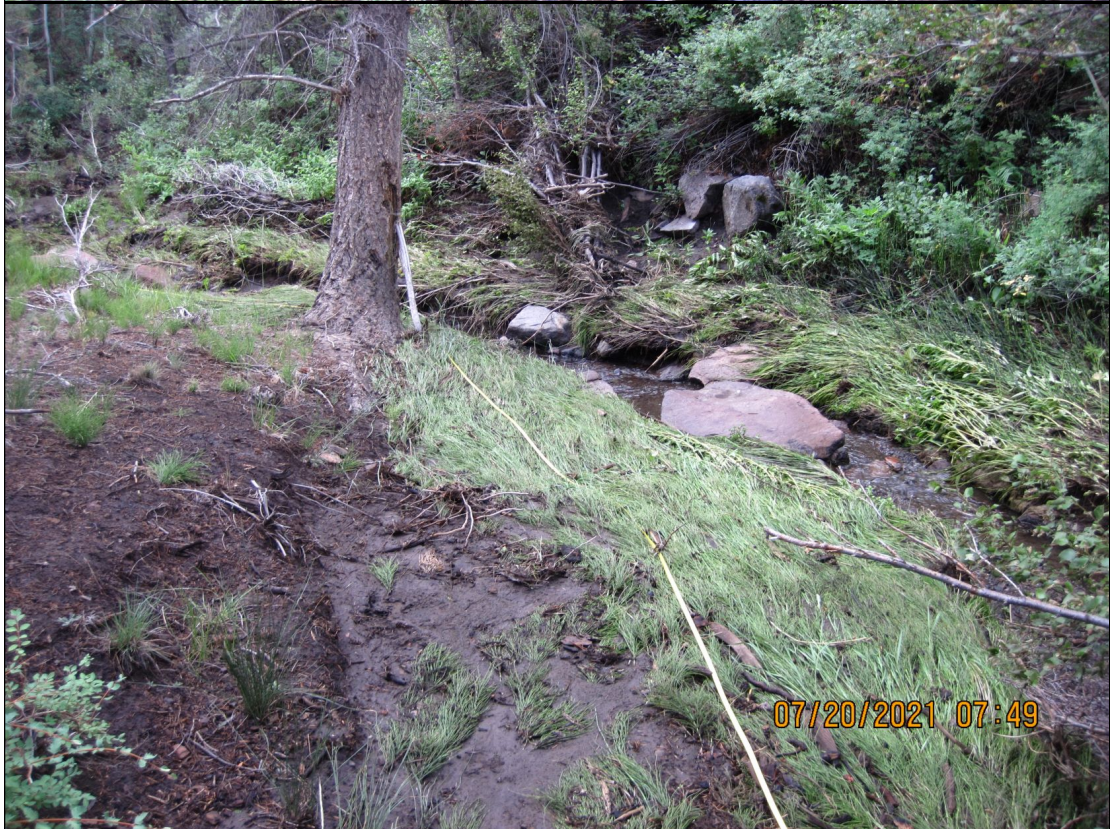
Evidence of recent flooding was observed in upper Delong Creek during BCT monitoring efforts in July 2021, four years after the 2017 Brian Head fire (Fig. 7). While it is unknown if this flood event would have been severe enough to impact habitat stability and fish survival, it did confirm that significant flows continue for years after a fire and must be considered in any decision regarding land or fish population management. Additionally, the cumulative effects of all post-fire flooding events impacted bank stability and fish habitat in Delong Creek. Grade control structures installed above and below culverts at road crossings were destroyed. Fish habitat was degraded as channel incision combined with subsequent sediment deposition within the incision to produce a wider, shallower channel with fewer pools than the pre-fire channel. Delong Creek is a relatively steep and confined channel where bank stability is controlled by rocks and other large structures, making it conducive to large woody debris placement, or the placement of other hardened structures. However, the presence of valuable infrastructure (forest roads and bridges; developed springs feeding the Panguitch City culinary water system) will need to be considered prior to

Figure 7. Evidence of flooding in upper Delong Creek in July 2021.

implementing such work. An evaluation should be completed in 2022 or 2023 to determine what work is feasible and warranted, and what funding may be available for implementation. Environmental compliance for stream restoration work was already completed for Delong Creek under the Brian Head Fire Rehabilitation project, so any implementation can occur immediately after planning and design.

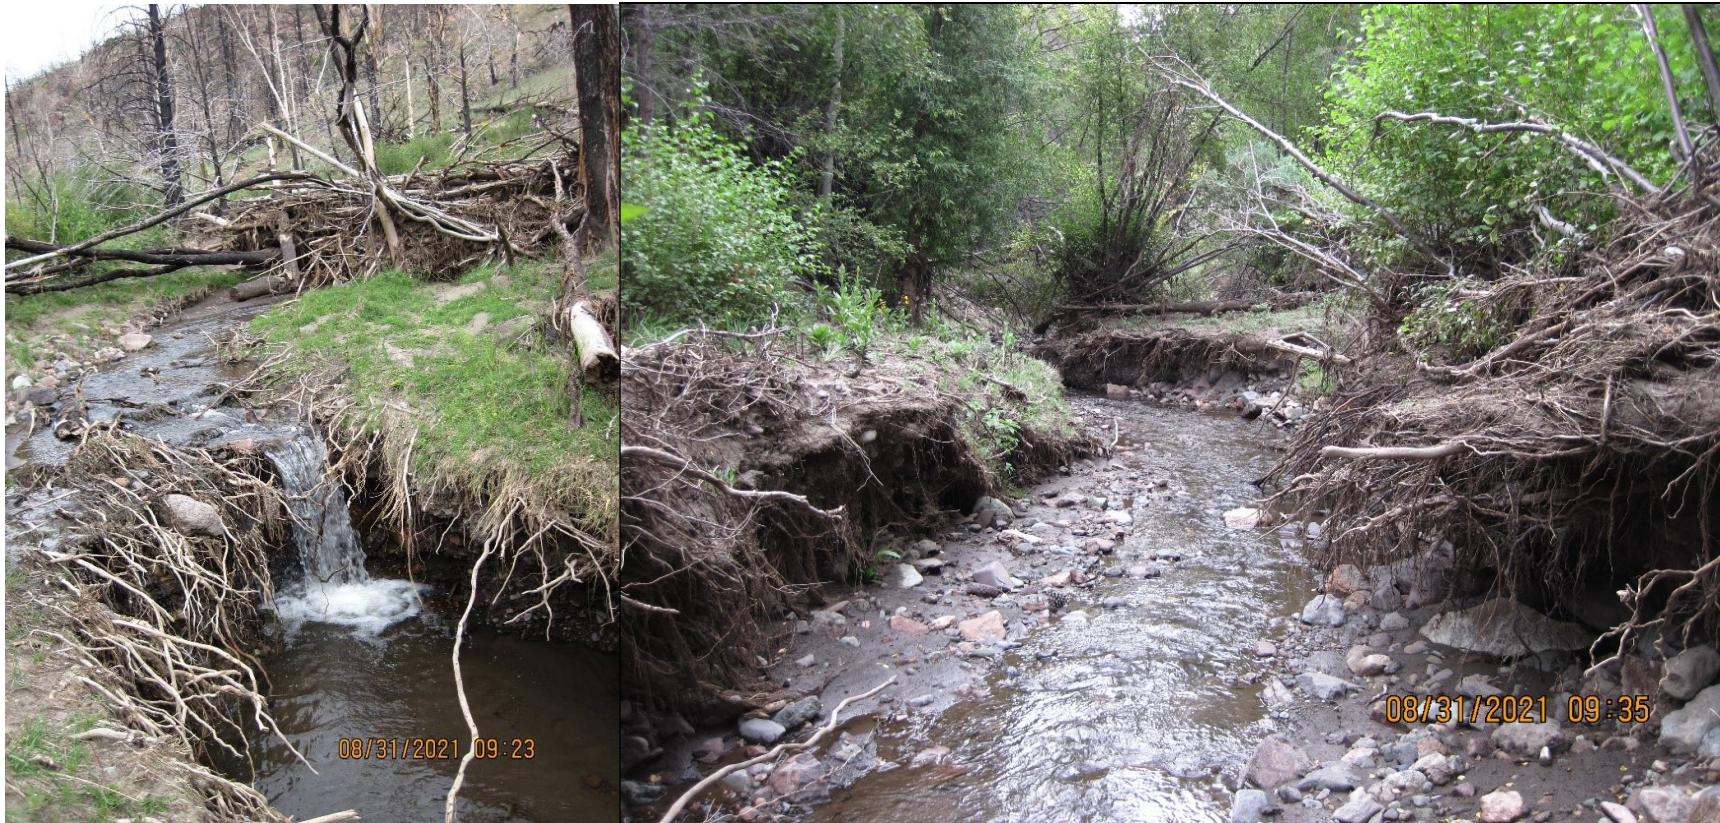
DWR conducted monitoring surveys in Threemile Creek in July 2021 and found the stream channel to be lacking in pool structure and dominated by riffles. During a complete walk-through of the stream from the Delong Creek confluence downstream to the DNF-BLM boundary in August 2021, DNF staff observed evidence of recent flooding, as well as the cumulative effects of flooding since the Brian Head Fire, including head cutting, channel incision, loss of bank stability, loss of riparian hydric species, and channel widening (Fig. 8). Channel erosion impacts were more prevalent in the upper reach, with the lower reach receiving sediment deposition from that erosion. Despite these impacts, woody riparian vegetation had maintained or was recovering in many areas, providing stream shading and cover.

In Threemile Creek's somewhat open valley, fine-grained soils dominate the bank substrate and bank stability is primarily controlled by strongly rooted riparian vegetation (e.g. sedge, willow, river birch). The case of Fish Creek (Middle Sevier River drainage), which was burned by the Twitchell Canyon Fire in 2010, can help illuminate the best approach to stream recovery after a fire in this stream type. Large woody debris was placed in Fish Creek four to five years after the fire as a temporary means of providing channel and bank stability, in addition to fish habitat, while riparian vegetation was reestablishing. Much of the debris was subsequently displaced out of the active stream channel by a long-duration high spring runoff event in 2019, four to five years after placement and nine years after the fire. Woody riparian plant species (primarily cottonwoods, but also including some willows and river birch) initially experienced favorable regeneration during a four-season period of reduced grazing after the fire. Following this incomplete resting period, livestock use in the riparian area resumed and eventually increased. Livestock began spending an inordinate amount of time in the riparian zone, despite abundant feed growth on adjacent upland benches and slopes. Since Fish Creek acts as the water source for several pastures, the riparian area experienced a constant, near season-long livestock presence, even when most livestock were grazing elsewhere on the allotment. Even though the number of livestock grazing the area at any time was relatively modest, continuous grazing pressure on the riparian habitat still resulted in a

Figure 8. Head cutting, channel incision, and channel widening observed in Threemile Creek in August 2021.

The example of Fish Creek demonstrated that active habitat restoration through placement of large woody debris and/or other hardened structures may not be effective for post-fire recovery in a low-gradient, open-valley channel type. In these channel types, maintaining existing riparian hydric species, or recovering them, may be the best strategy for preventing channel degradation and fish habitat loss. Limiting grazing pressure on riparian vegetation – both prior to disturbance and long enough after disturbance that the strongly-rooted species become fully established and resilient to livestock use – holds a greater potential for both short-term recovery and long-term stability.

Only the upper reaches of Threemile Creek were burned over by the Brian Head fire, leaving a large portion of the riparian area unburned. Previous overuse of this pasture had already prompted implementation of a rest period in 2012, five years before the fire. This period of rest continued through 2018 and was followed by limited use by livestock moving on and off the Forest. Despite unauthorized, continued overuse of the pasture during the rest period (similar season-long grazing by a limited number of livestock as discussed in the Fish Creek example), the mature woody riparian species were maintained throughout much of the Threemile Creek drainage below the Delong Creek confluence. This vegetation, coupled with the wide valley bottom, helped to defray some of the erosive energy of post-fire stream flows. Uplands surrounding the burned-over Threemile-Delong confluence experienced considerable aspen regeneration following the fire, which may have helped defray use by livestock and other wild ungulates; although much of this regeneration is still not past the point of being impacted by browse pressure. As discussed previously, while initial impacts to channel stability were not as great in Threemile Creek, the long-term runoff changes following the fire do appear to be degrading at least the upper portions of the channel below the Delong confluence. The existing riparian woody vegetation in Threemile Creek has facilitated the use of beavers as a cost-effective tool to maintain and improve channel form and function. In 2021, DWR and DNF partnered to introduce fourteen beavers to Threemile

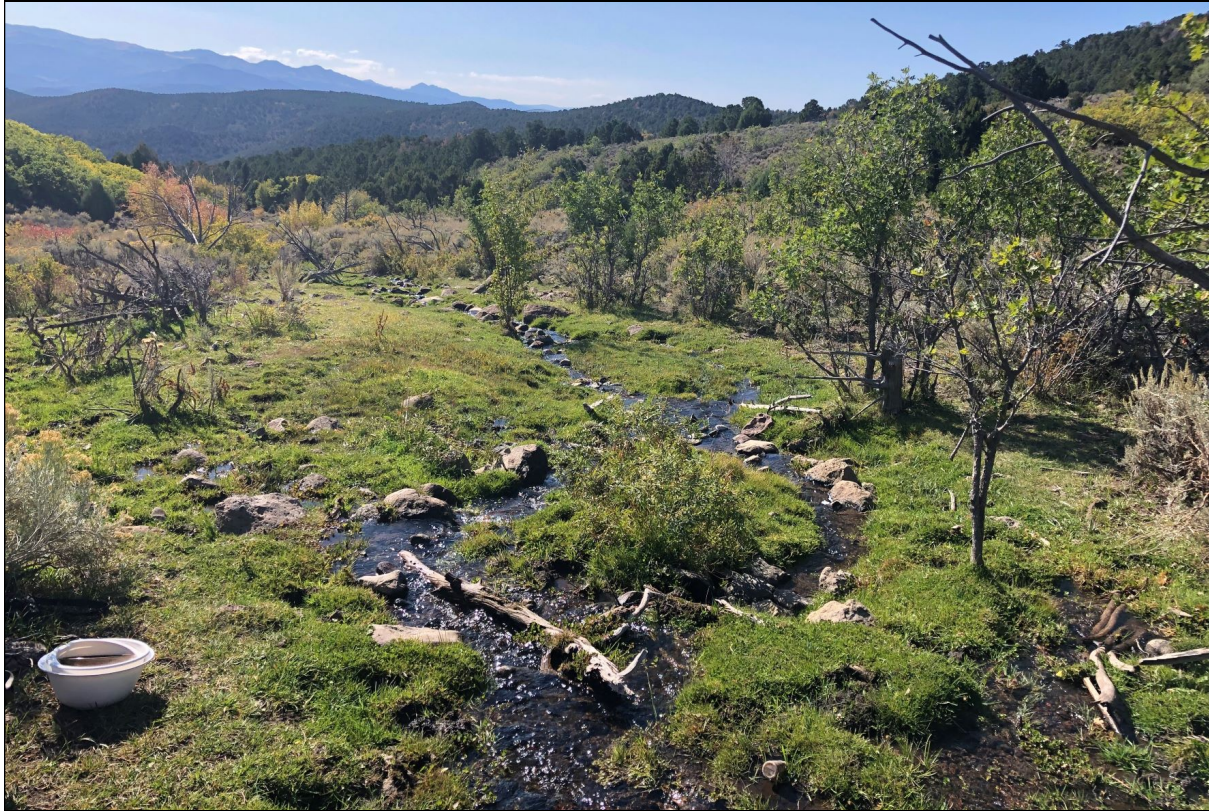
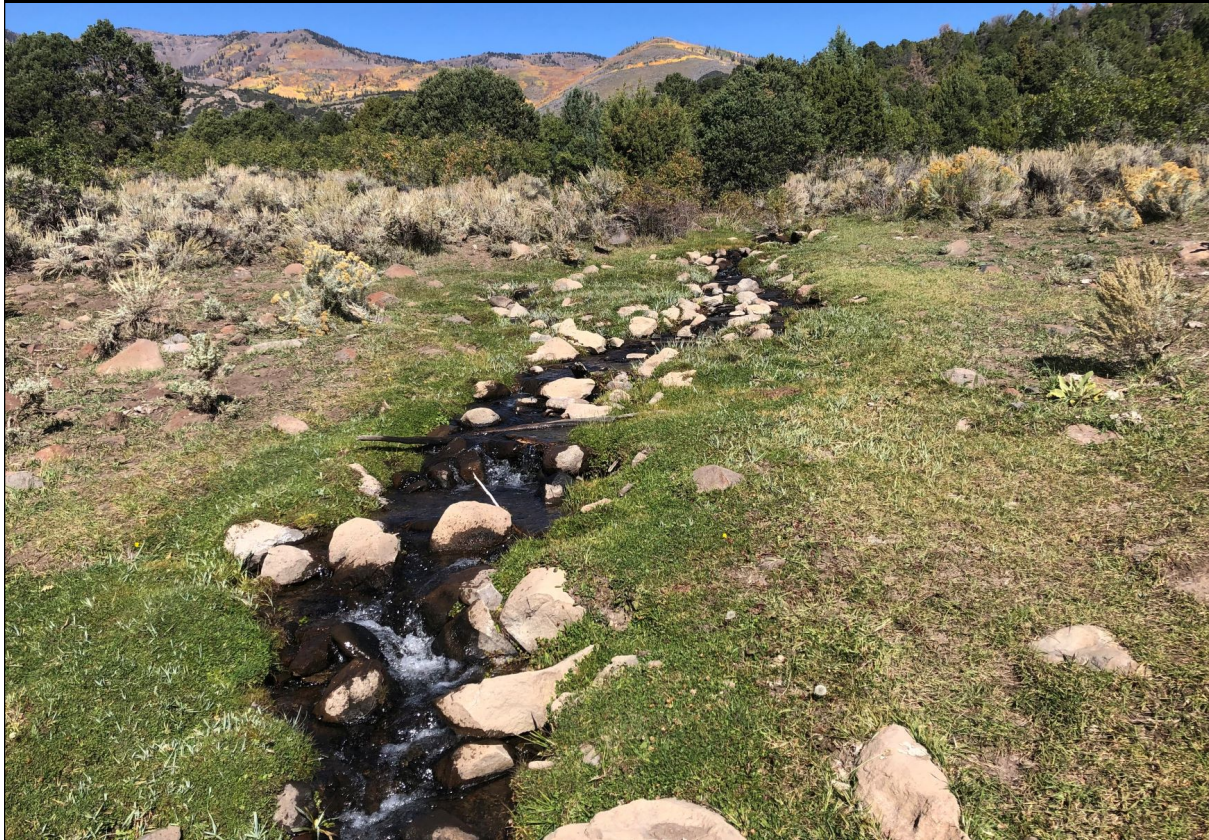
Birch Creek Station 2 sits within the 1996 fire perimeter and is grazed heavily. This station, as well as other stations in Birch Creek, has historically exhibited BCT biomass measures below average for southern Utah trout streams (Platts and McHenry 1988, Hepworth and Beckstrom 2004). Station 3 is also located within the fire perimeter but is mostly shaded and protected from grazing by an island of woody shrub vegetation. BCT biomass here has remained fairly constant across the years, likely because of more consistent flow in this middle stream reach, better habitat conditions, and less grazing impacts. Station 4 is located within the fire perimeter but was in an island of burned and unburned conifer. BCT biomass was high at this station in 2008, perhaps due to fish being reintroduced into this area in preceding years, with the standing and down timber providing protection from grazing. Biomass had declined by 2021, which may be attributed to a combination of increasing livestock access to the reach, decreased flow, and drought-related habitat impacts.

Figure 9. Birch Creek Station 2, showing short riparian herbaceous stubble height and sparse riparian woody shrub vegetation.

Given how extreme the recent drought has been, it was heartening to see that BCT still occupied Birch Creek to the extent and abundance observed in 2021. Across the years, however, livestock use of the open areas within the 1996 fire perimeter has remained high, with riparian herbaceous stubble heights observed to be shorter than the four-inch minimum standard for hydric species that applies to all riparian areas on the FNF (USDA Forest Service 2001) (Fig. 9). Birch Creek was initially rested from livestock for four years after the 1996 fire to help aspen recover

and grow tall enough to escape grazing, which did occur in many areas. Riparian woody shrub species have not recovered so well, however, and the heavier grazing use in open stream reaches continues to limit their recruitment. Increasing willows and having taller and more vigorous lateral herbaceous riparian plants would increase stream shading, improve habitat complexity, and help protect streambanks. The decrease in BCT biomass and occupied stream length observed in Birch Creek in 2021 demonstrates that properly administering land uses to ensure Forest Plan standards are being met is essential for securing the long-term viability of this BCT population.
