**BONNEVILLE CUTTHROAT TROUT RESTORATION IN THE MAMMOTH CREEK  
DRAINAGE: 2020 ACTIVITIES**

January 2021

Utah Division of Wildlife Resources  
Southern Region

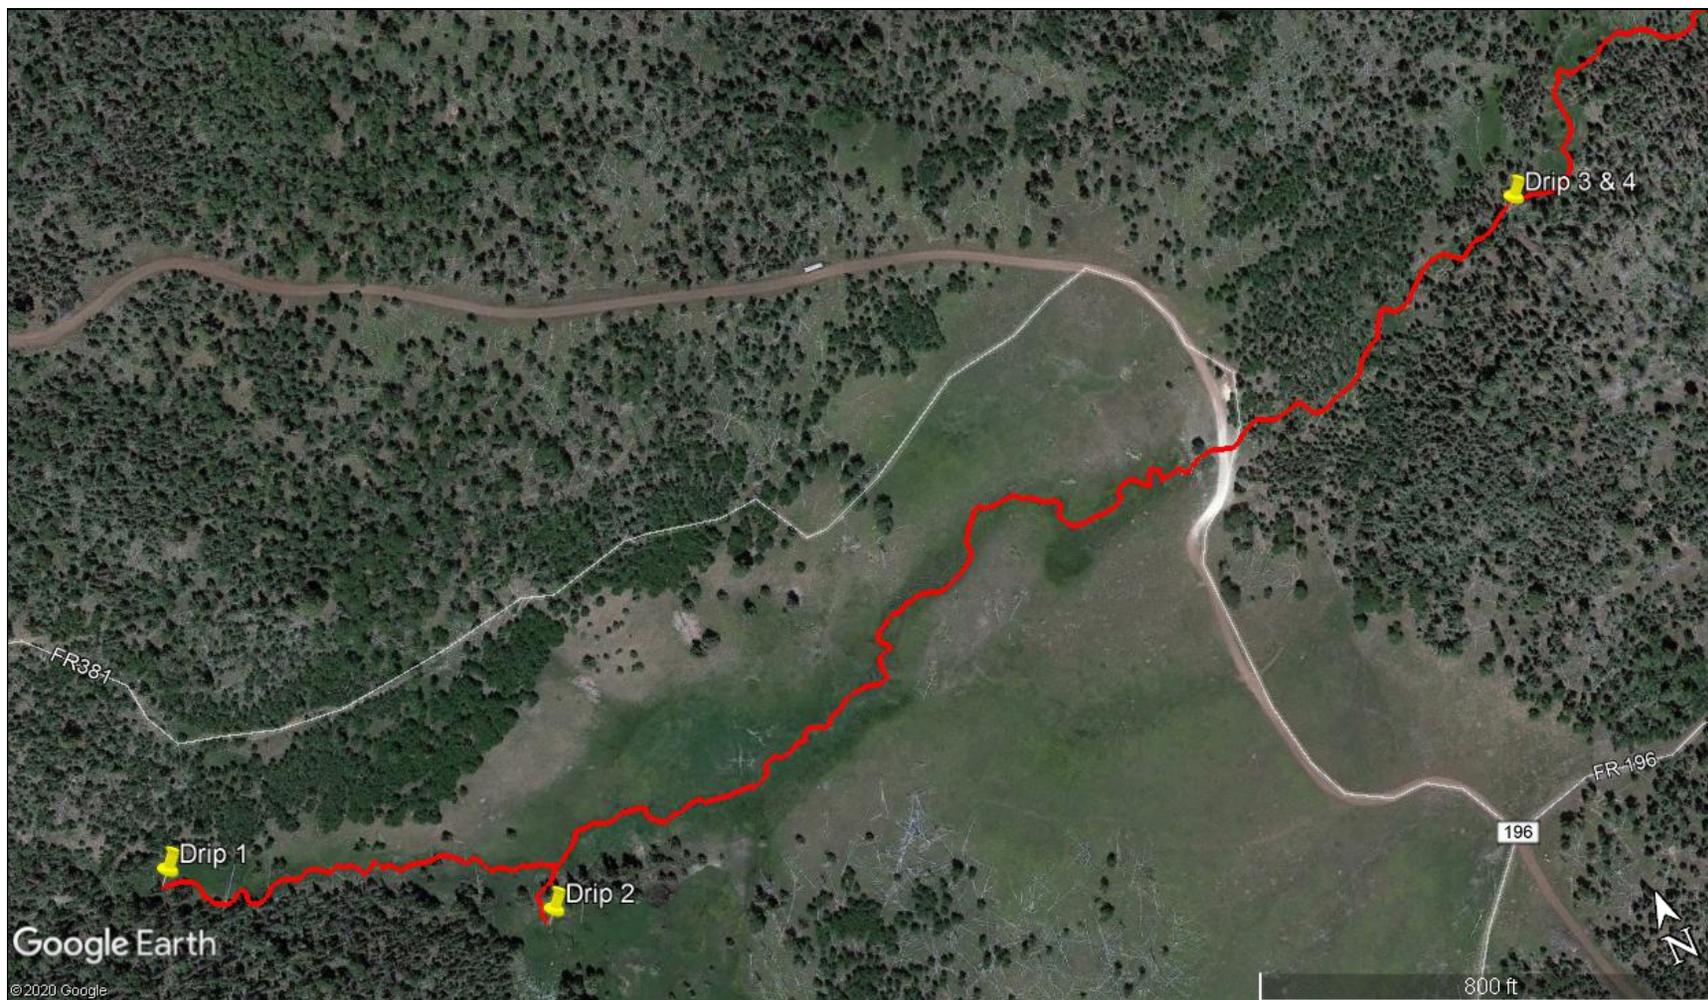
Figure 4. Locations of rotenone drip stations in upper Reed Valley Creek.

Liquid rotenone was applied to target waters in Reed Valley Creek on July 6 and 7, 2020, using three 35-gal (7-hr charge) drip barrels and one 7-gal (4-hr charge) drip barrel. The 35-gal barrels were set in the stream in upper Reed Valley (Drip 1) (Fig. 4), the main Reed Valley spring (Drip 2), and a spring (Drip 3) 0.65 mi downstream of the top drip. Drip 3 was close enough to the treatment midpoint that it was run as a booster. The 7-gal barrel (Drip 4) was set in another spring next to Drip 3. Spray crews were assigned to inspect the entire treatment area for potential refugia and areas of low mixing and applied rotenone to these sites with backpack sprayers.

Drips 1-3 were set in Reed Valley Creek at 11:00 pm on July 6 (Fig. 4). Although all of these drips were set for one 7-hr charge, Drips 1 and 2 emptied more slowly than anticipated and ran for about 10 hours before being pulled. Similar slow application rate also happened at these drips in 2019, though the resulting rotenone concentration still proved sufficiently lethal. Drip 3 was pulled after running just over 8 hours. Drip 4 was run for a single 2-hr charge on the morning of July 7. A total of 1.02 gal (3.87 L) of rotenone was applied to Reed Valley Creek on July 6 and 7 (Table 3) – 0.54 gal by drip stations and 0.48 gal by sprayers. Approximately 2.76 miles (4.44 km) of stream were treated with rotenone (Table 4). No fish were observed in the target area.

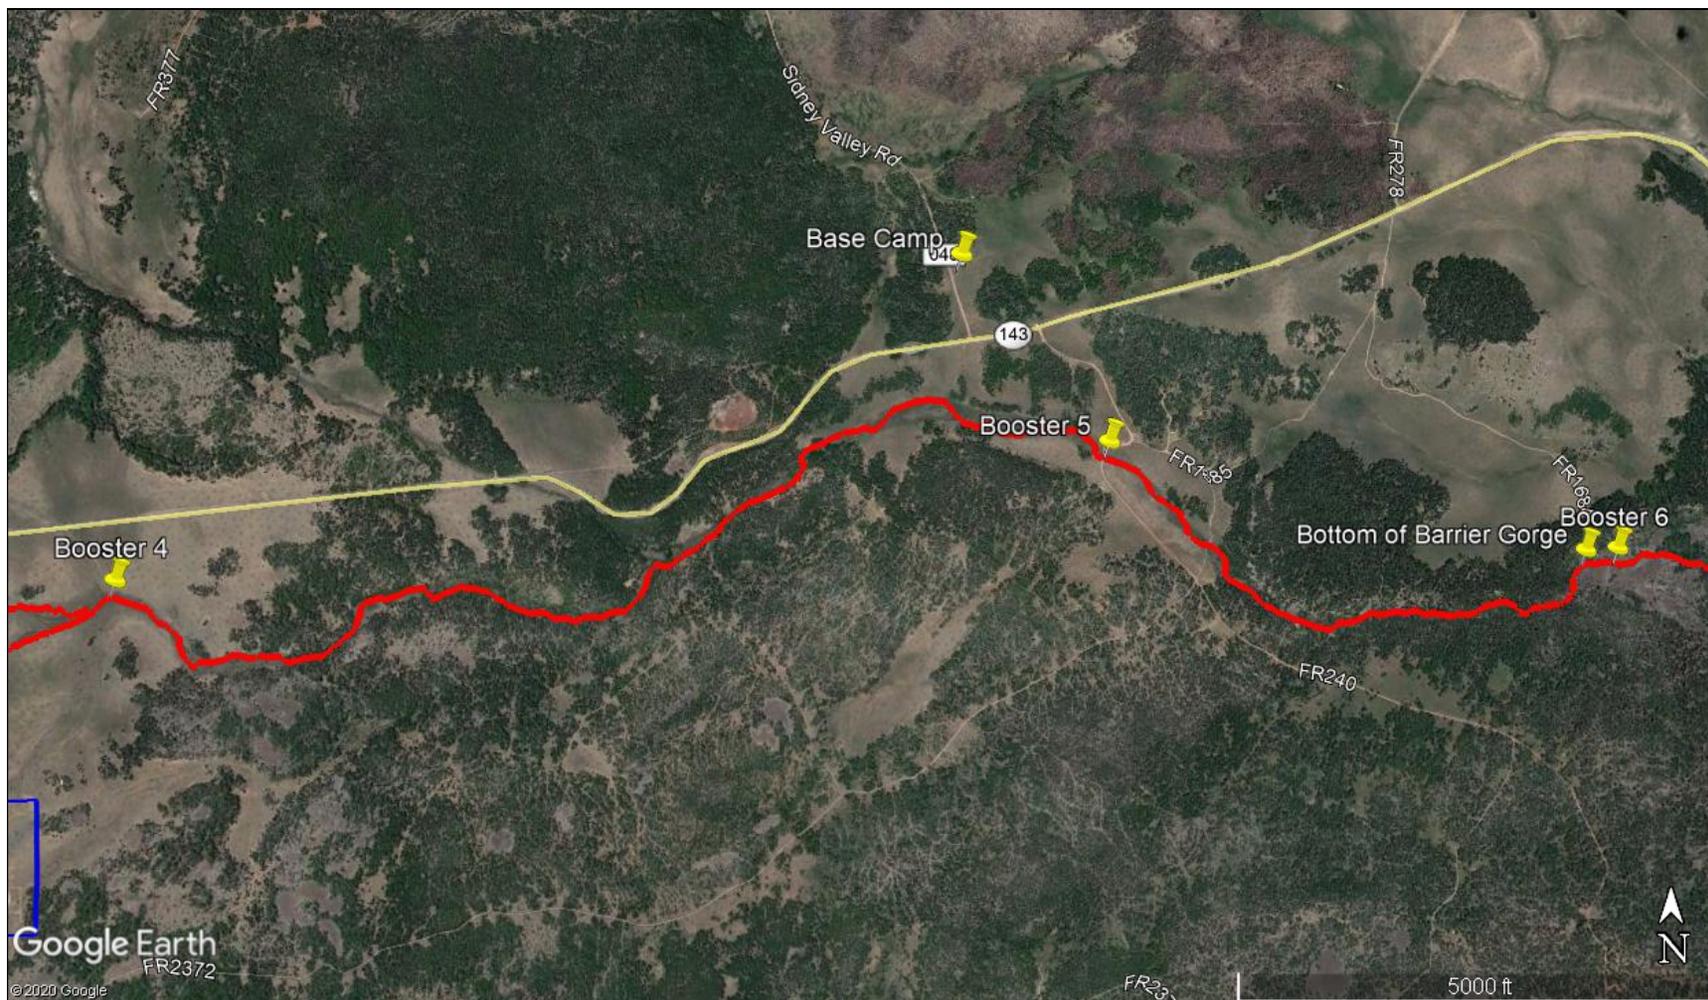
Figure 10. Locations of rotenone drip stations set in the Red Desert reach of Mammoth Creek.

As in higher reaches, rotenone was observed to move more slowly through the reaches between Boosters 4 and 6 (Fig. 10, Table 2). Very few fish were observed between Booster 5 and the waterfalls. Spray crews moved slowly to stay behind the rotenone front and ensured that complete coverage was achieved. Reduced flow had already been noted in reaches below the waterfalls (Fig. 11-13) and adjusted application plans successfully addressed those reductions. The rotenone charge in Drip 14 (Castle Creek) was increased to treat the entire flow of Mammoth Creek, while Booster 6 was moved to below the waterfalls and changed to a 7-gal drip. The dry reach in the lower treatment section had grown to 0.29 mi on August 5.

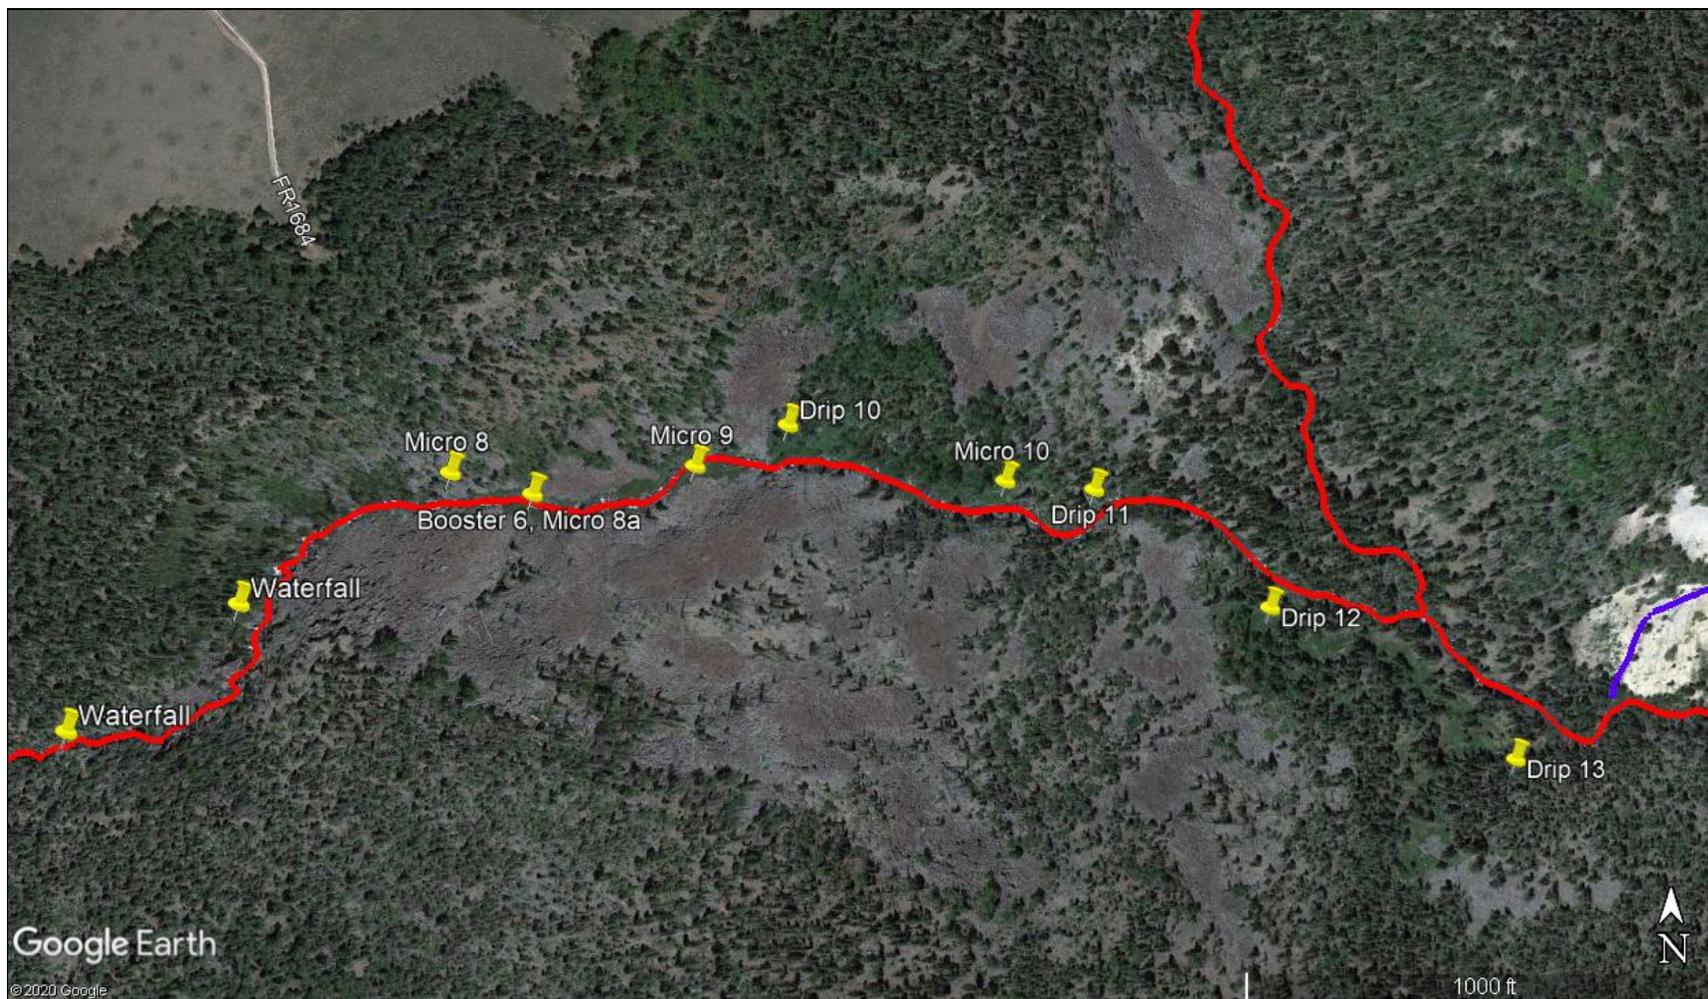
Figure 12. Detailed view of the waterfall gorge reach of Mammoth Creek, with rotenone drip stations.
